REPORT No. 829

SUMMARY OF MEASUREMENTS IN LANGLEY FULL-SCALE TUNNEL OF MAXIMUM LIFT COEFFICIENTS AND STALLING CHARACTERISTICS OF AIRPLANES

By HAROLD H. SWEBERG and RICHARD C. DINGELDEIN

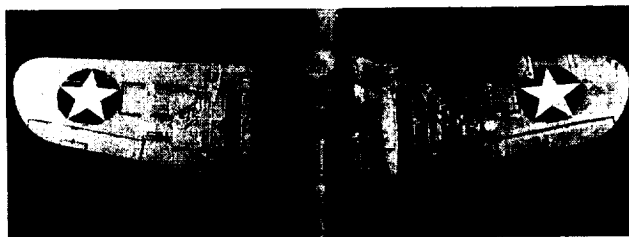
FIGURE 14.—Effect of wing surface roughness on the $C_{l_{max}}$ of airplane 6. Propeller removed; $\delta_l = 0^\circ$; approximate test velocity, 60 miles per hour.

The maximum lift coefficients obtained for airplane 6 with the wing in service condition and with the wing completely faired and sealed are compared in figure 14. As shown by the photographs included in figure 14, the service wing has an exceptionally large number of cover plates, access doors, and construction irregularities. In addition, a rough walkway projects more than $\frac{1}{8}$ inch from the wing surface and the wing fold line leaves a large gap in the wing. The maximum lift coefficient was only 1.17 for this airplane with the wing in the service condition. When the wing was faired and sealed by masking tape, as shown in figure 14, the $C_{l_{max}}$ was increased to 1.26. The tape seals eliminated leakage through the wing; nevertheless, the wing was not smooth and the $C_{l_{max}}$ remained relatively low.

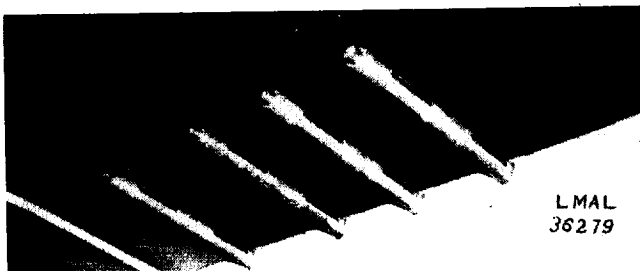
FIGURE 23. Eighteen-inch barrel extension in low position on right wing. Airplane 11.
